# Manhole Inspection Summary

Manhole # S41E\_\_010MH

Insp Date: **5/22/08 11:53 AM**

**Location** Address: **rear 11 lombard st**

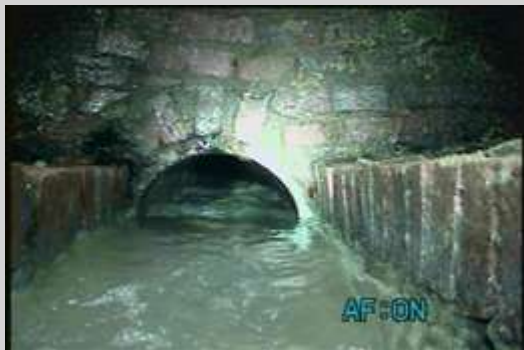
12 O'Clock Outflow

8 in. Circular Gravity Sewer  
Pipe Out @ 12 O'Clock

Pipe Material: **Clay** ☐ Pipe Lined

Invert Depth: **13.38** (ft.) Flow Characteristics: **Fast**

Infiltration: **None** Pipe Seal Cond: **Unknown**

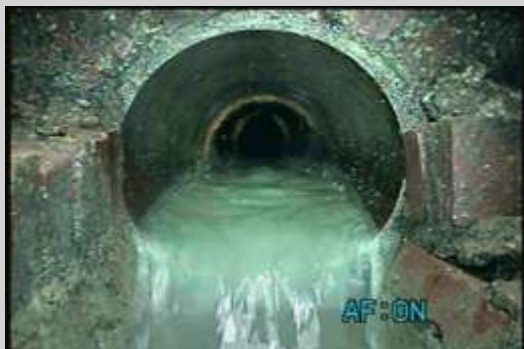
6 O'Clock Inflow

8 in. Circular Gravity Sewer  
Pipe In @ 6 O'Clock

Pipe Material: **Clay** ☐ Pipe Lined

Invert Depth: **13.19** (ft.) Flow Characteristics: **Fast**

Infiltration: **None** Pipe Seal Cond: **Unknown**

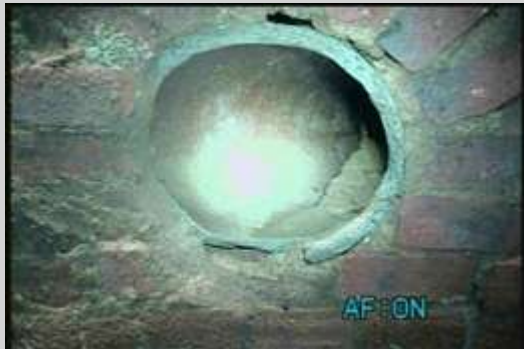
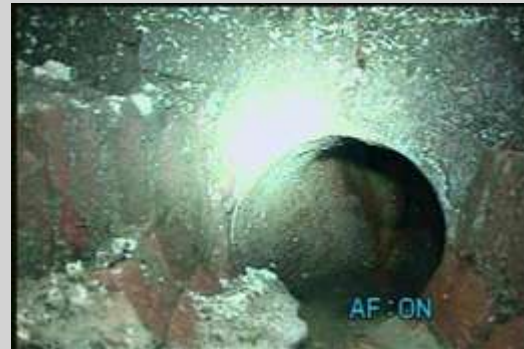
9 O'Clock Inflow

8 in. Circular Gravity Sewer

Pipe In @ 9 O'Clock

Drop In @ 9 O'Clock

Pipe Material: **Clay** ☐ Pipe Lined

Infiltration: **None** Pipe Seal Cond: **Unknown**

Drop Condition: **Open**
